INDOOR AIR QUALITY REASSESSMENT

**Massachusetts Office of Information Technology
One Ashburton Place, 8th floor
Boston, MA**

Prepared by:
Massachusetts Department of Public Health
Bureau of Environmental Health
Indoor Air Quality Program
June 2017

Building:	MA Office of Information Technology (MassIT)
Address:	One Ashburton Place, 8 th floor
Assessment Requested by:	Chris N. Benanti, IT Facilities Manager, MassIT
Reason for Request:	Reassessment of general indoor air quality (IAQ) concerns including odors
Date of Assessment:	June 16, 2017
Massachusetts Department of Public Health/Bureau of Environmental Health (MDPH/BEH) Staff Conducting Assessment:	Ruth Alfasso, Environmental Engineer, IAQ Program
Building Description:	One Ashburton Place, also known as the McCormack Building, is a large state office building constructed in the 1970s.
Windows:	Not openable

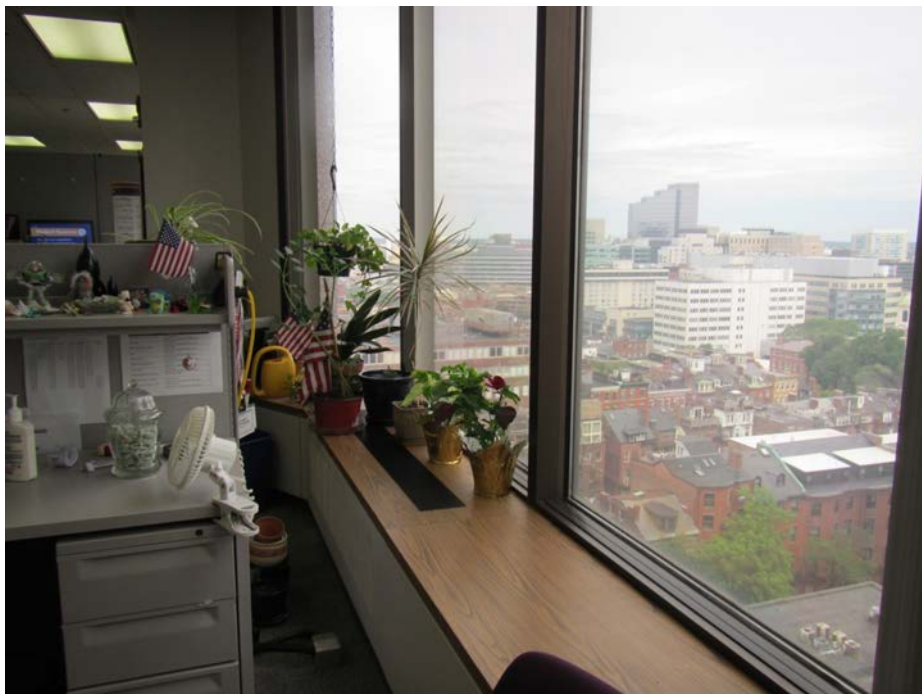
Picture 2

Fresh air is supplied by induction units located along the outer edges of the building (Pictures 1 and 2). Return air is drawn through grates or around light fixtures using ducted returns. As shown in Picture 2, some induction units had items on top of them, which can obstruct the flow of fresh air. In addition, some of the items on/near the vents of the induction units can be a source of dusts, odors and, in the case of plants, pollen, and other potential allergens. Induction unit vents should be kept free of items and kept clean.

Plants were noted in a few areas (Table 1; Picture 2). Plants can be a source of pollen and mold, which can be respiratory irritants to some individuals. Plants should be properly

Induction unit with plants on it

6. Keep plants in good condition, avoid overwatering, and remove from the airstream of heating and ventilation equipment.
7. Reduce the use of cleaning products, sanitizers, and other items that contain VOCs.

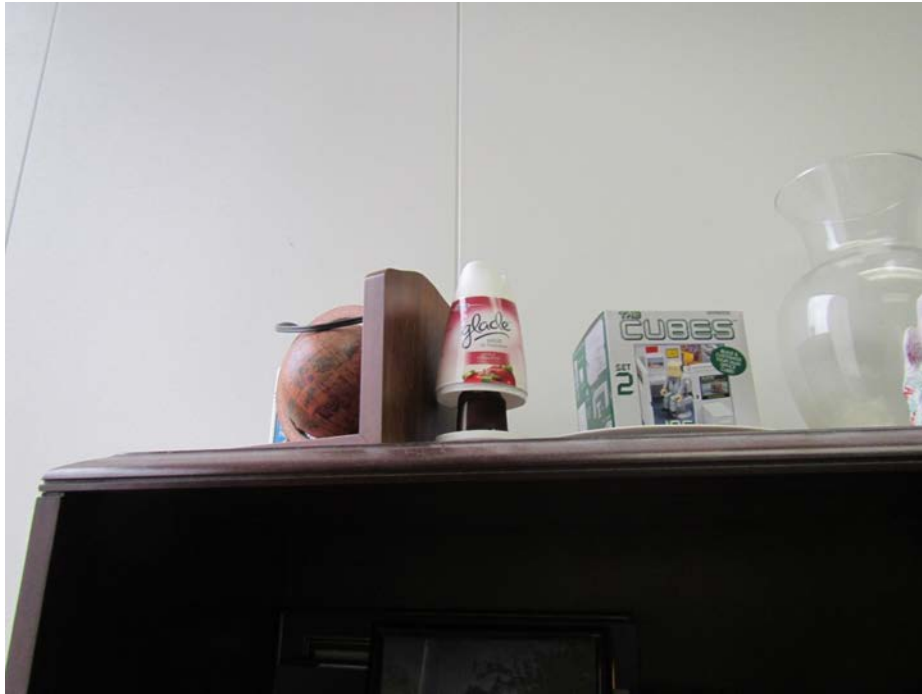
Picture 3

Exposure to low levels of TVOCs may produce eye, nose, throat, and/or respiratory irritation in some sensitive individuals. In addition to testing, BEH/IAQ staff examined spaces for products containing VOCs. BEH/IAQ staff noted air fresheners, deodorizers, hand sanitizers, cleaning products, compressed air canister, and dry erase materials in a number of areas throughout the office space (Table 1; Picture 3). All of these products have the potential to be irritants to the eyes, nose, throat, and respiratory system of sensitive individuals.

Air freshener

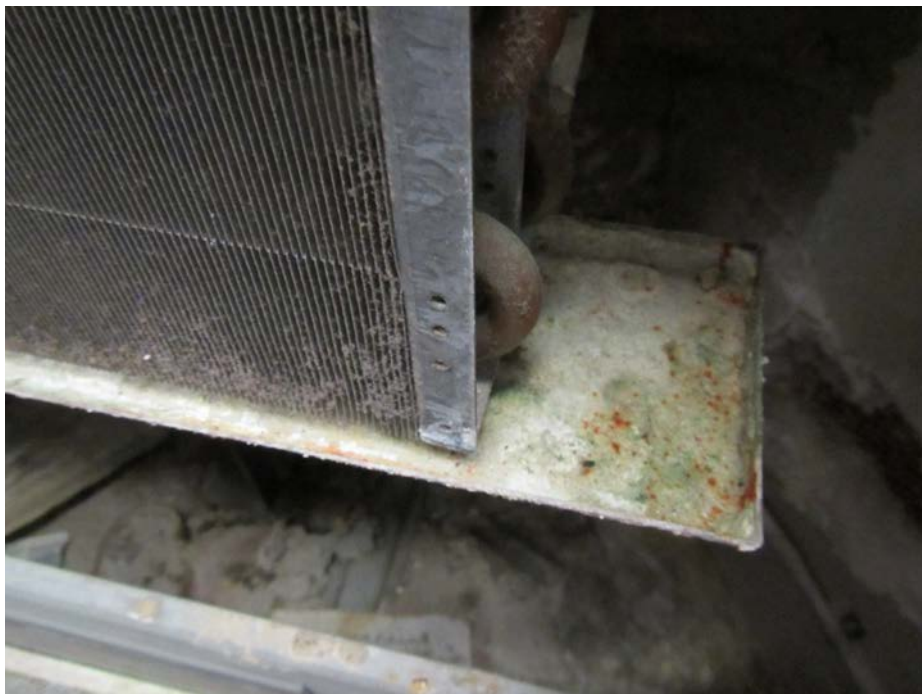
Picture 4

MassIT staff reported that musty odors occur in offices when the HVAC system switches between heating and cooling. A slight musty odor was detected in a few offices. Several of the induction units were opened for examination. Debris was observed inside the cabinets (Pictures 4 and 5), including dust on the fins and debris inside the condensation collection pans. Some collection pans also had small tablets, which are designed to reduce the build-up of microbial growth and clogs. Some of these treatments have components that may be irritating to the skin or respiratory system. The inside of the induction units, including the condensation pans, should be cleaned periodically to prevent odors and dusts from becoming aerosolized during unit use.

The office suites investigated are partially built on a raised floor, because area once served as a mainframe computer room. The area underneath the floor was found to contain significant amounts of debris (Picture 6) likely present since this office space was renovated. As shown in Pictures 4 and 5, this space is directly connected to the induction units, creating a pathway for dust, odors, and pests into occupied space. This space should be thoroughly cleaned.

Inside induction unit, note dusty fins, debris in condensation tray and space underneath

1. Regularly clean induction unit fins and condensation pans to reduce accumulated debris. Ensure tablets used in condensation pans to control microbial growth do not contain irritating substances or create odors.

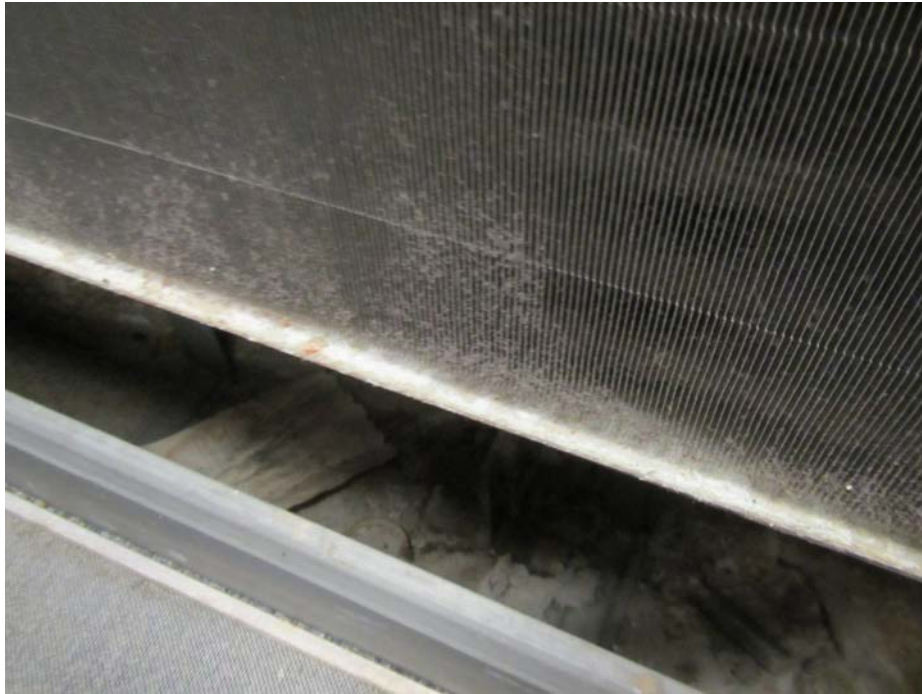
Picture 5

View inside induction unit showing dusty fins and debris in space below

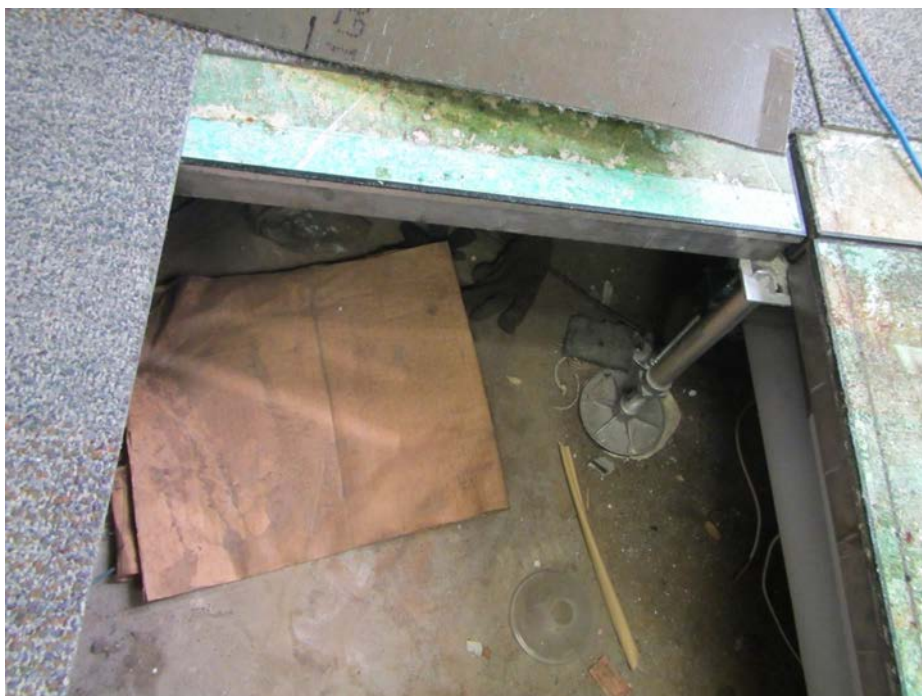
Picture 6

View under raised floor showing significant debris

2. Thoroughly clean the space underneath the raised floor.
3. Ensure that during cooling season, the temperature of the supply coil is above the dew point of the office areas to avoid any condensation at/inside the unit.

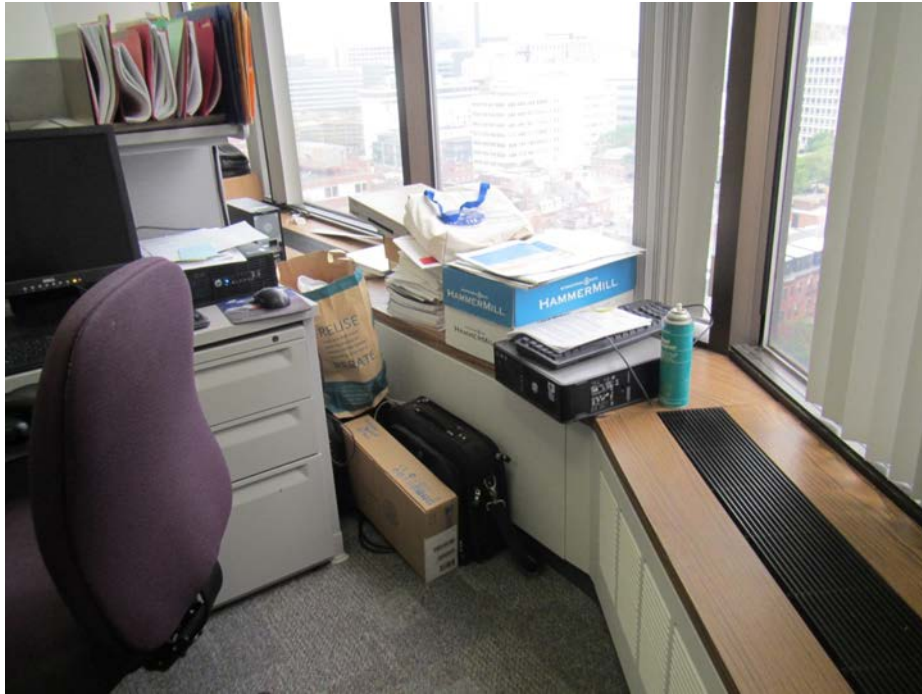
Picture 7

Items were observed on a number of flat surfaces, such as windowsills, tabletops, counters, bookcases, and desks (Picture 7). Items stored in offices provides a source for dusts to accumulate. These items (e.g. papers, folders, boxes) also make it difficult for custodial staff to clean. Items should be relocated and/or be cleaned periodically to avoid excessive dust build up.

Items on surfaces next to windows

8. Reduce the amount of items stored on flat surfaces to allow regular cleaning.
9. Clean carpeting in accordance with IICRC recommendations (IICRC, 2012).

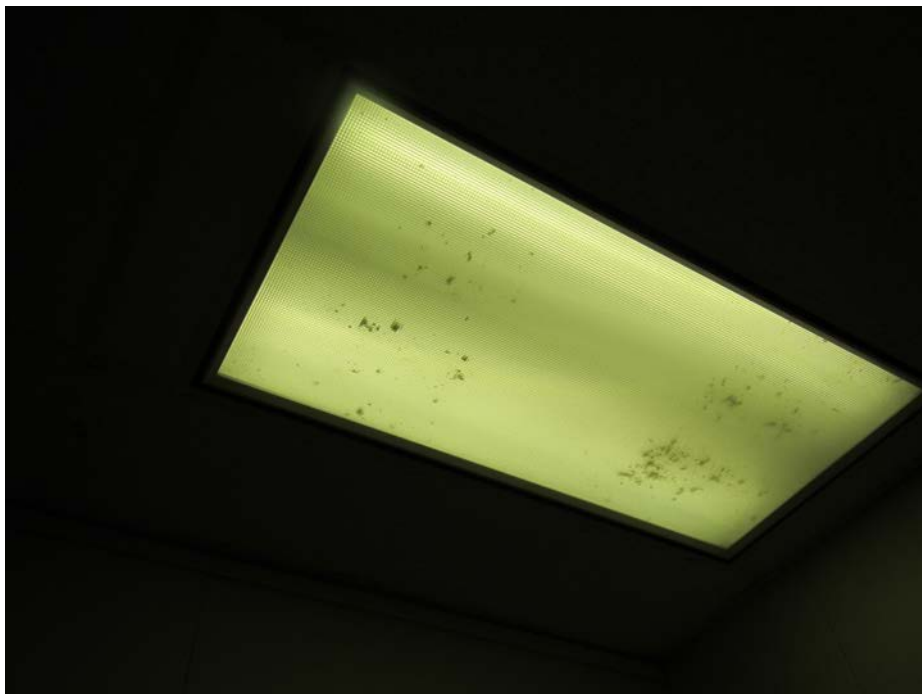
Picture 8

Some of the fluorescent light fixtures had debris visible inside them (Picture 8), a condition also observed during the previous visit. These fixtures should be cleaned periodically, and care should be taken to avoid aerosolizing the debris when the fixtures are opened. Any debris dislodged during cleaning should be vacuumed using a high efficiency particle arrestance (HEPA) filtered vacuum. This activity should be conducted outside of normal working hours.

Debris inside light fixture

10. Clean light fixtures of debris; ensure debris is properly contained and cleaned up to prevent aerosolization.
11. Refer to resource manual and other related IAQ documents located on the MDPH's website for further building-wide evaluations and advice on maintaining public buildings. These documents are available at: <http://mass.gov/dph/iaq>.
